Screw Conveyor Shaft Wear Solution

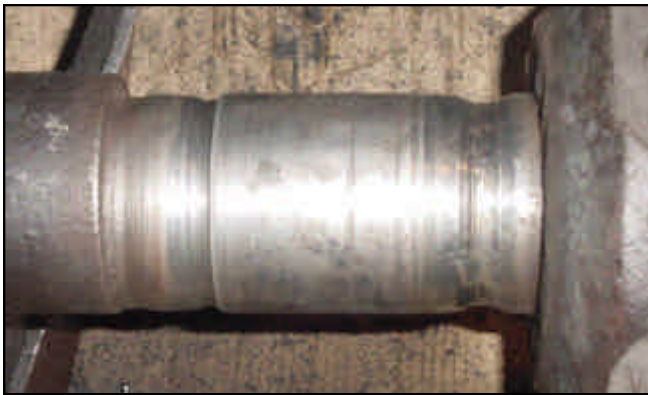
A customer was having problems with rubbing seals which were creating excessive wear and damage to screw conveyor shafts on an animal feed conveyor. This created high maintenance costs and limited operational use of the conveyor.

Above: Typical annual shaft damage prior to conversion.

To rectify the problem, Cooper recommended shaft wear collars to be fitted to either side of the OIE 90mm EX (Expansion) bearing installed in a special strap hanger application on the shaft of the screw conveyor.

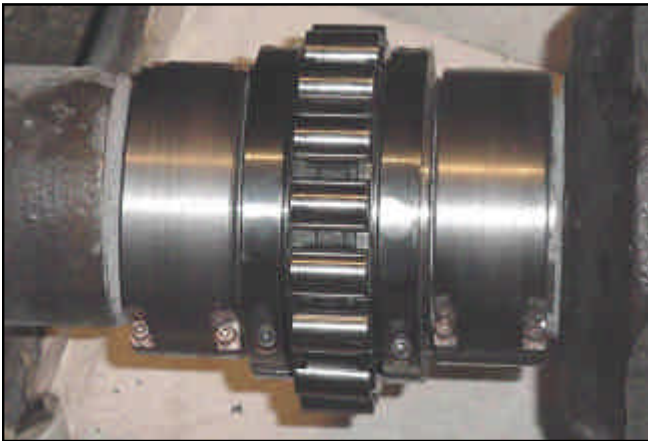
Below: Wear collars shown in position before fitting of housing.

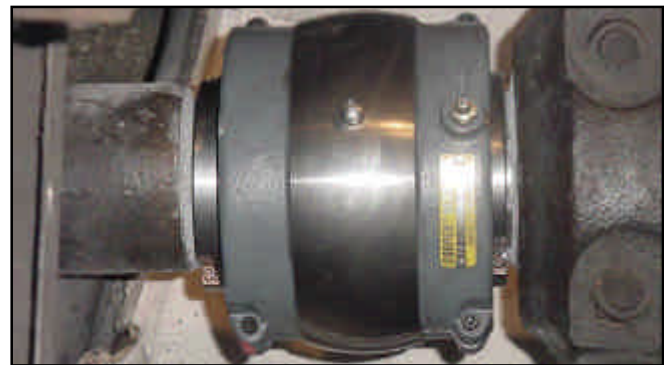
Below: Installation of cartridge in screw conveyor.

The application required special modification to the cartridge and enabled the screw conveyor to operate continuously throughout the processing period without the need for any bearing or seal related stoppage. This has resulted in significant cost savings for the customer.
